SURVEY REPORT #1049J21

Vessel Name: "TEMMA"

Where Surveyed: On the hard @ Sakonnet South Yard, Portsmouth RI, In the water alongside at Bowen's Wharf, Newport RI.

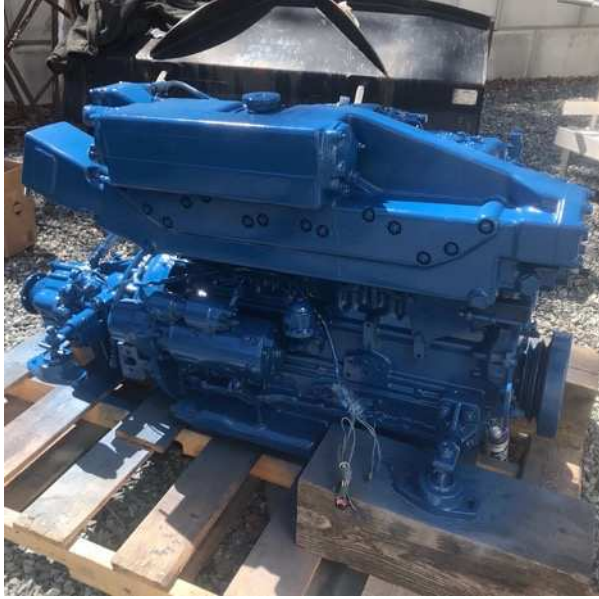
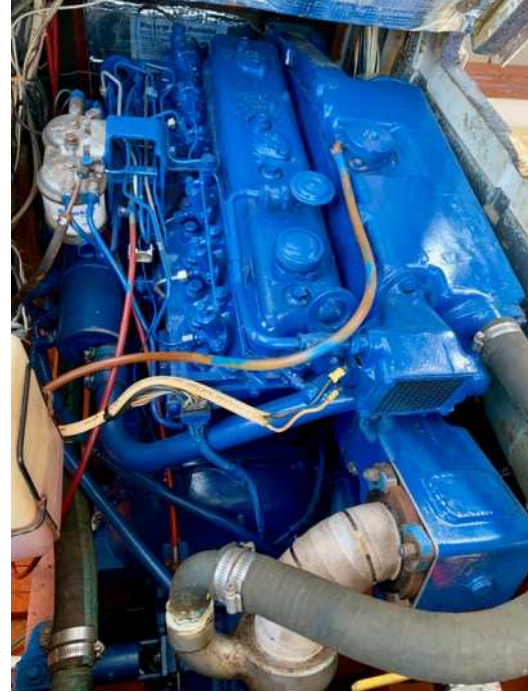
General Condition: The engine was out of the vessel this past haulout period. It was repainted, injection pump rebuilt, injectors serviced, raw water and coolant pumps replaced, heat exchanger serviced, and all hoses replaced. The transmission was sent out for overhaul at the same time. The engine and transmission were both operated briefly alongside. The engine exhibited good compression with a quick start and quick shut down. The transmission engaged smoothly and the shaft appeared straight and true by virtue of no undue vibration. Photos show engine out and repainted in the spring, and engine reinstalled in July.

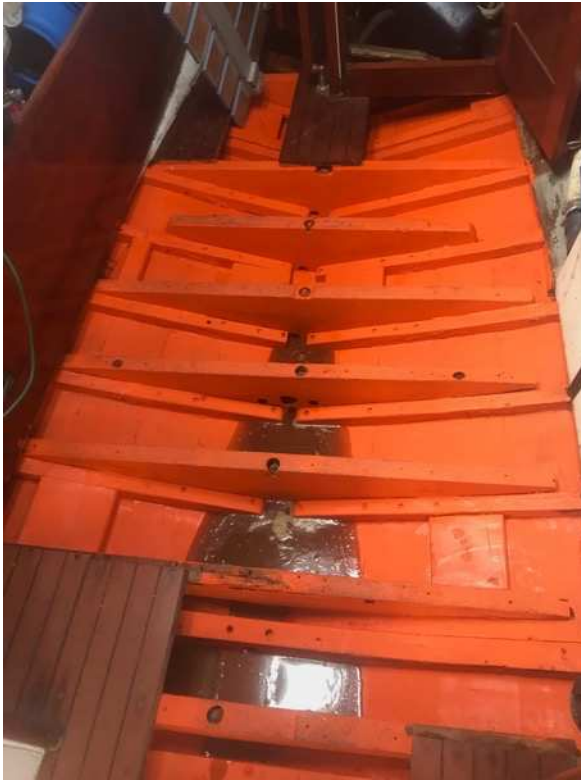
Main bilge after keel floor and frame heel work spring 2021

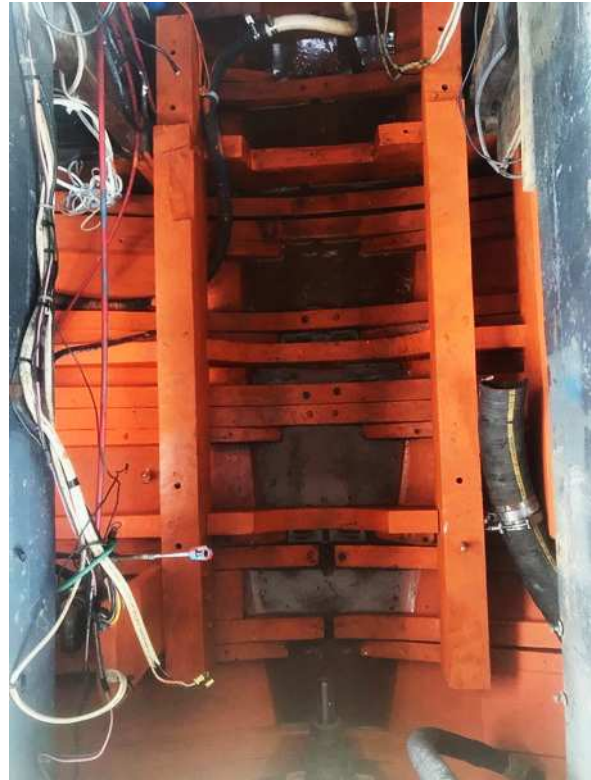
Engine bilge with engine out, floors and frames inspected and re-painted
